Assessment of Photovoltaic Module Failures in the Field

Report IEA-PVPS T13-09:2017

IEA PVPS Task 13, Subtask 3
Report IEA-PVPS T13-09:2017
May 2017

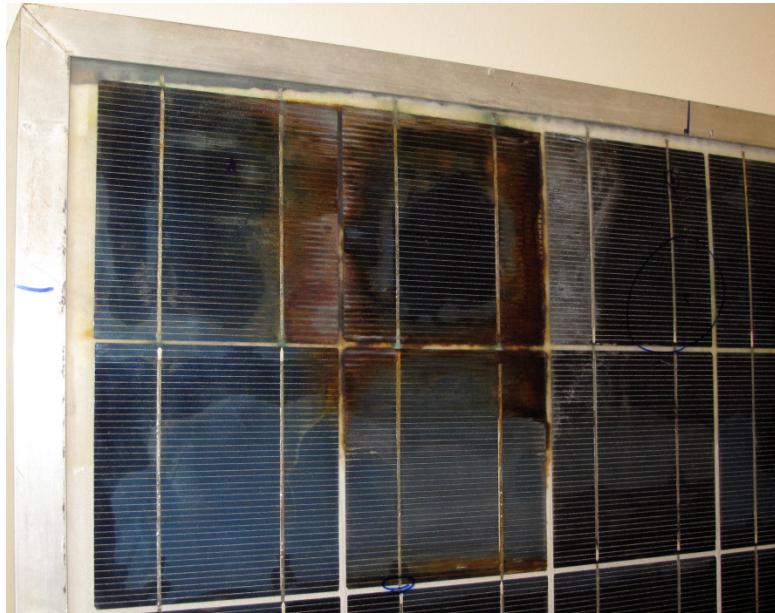
Fig. 4: Glass/glass module with specific ionomer encapsulant type that has proven to have insufficient adhesion, showing delamination and corrosion.

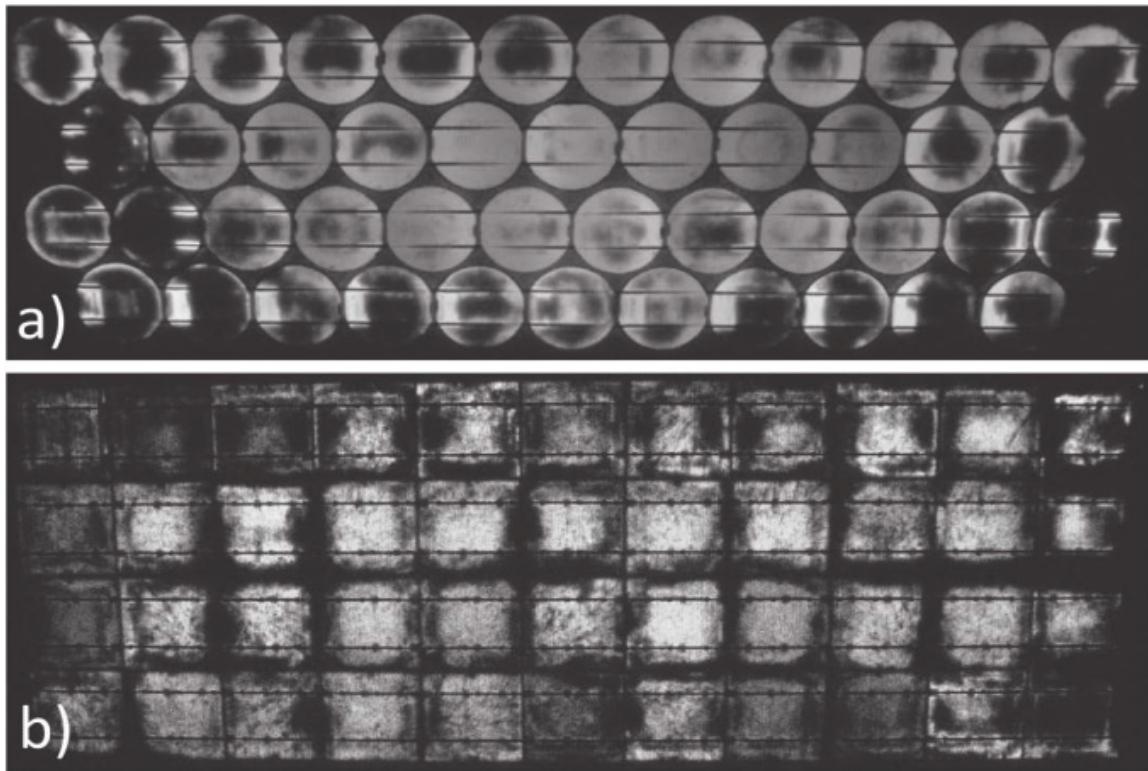
Fig. 21: EL images of PV modules exposed at Cfa climate in Köppen climate classification in Japan over 30 years.

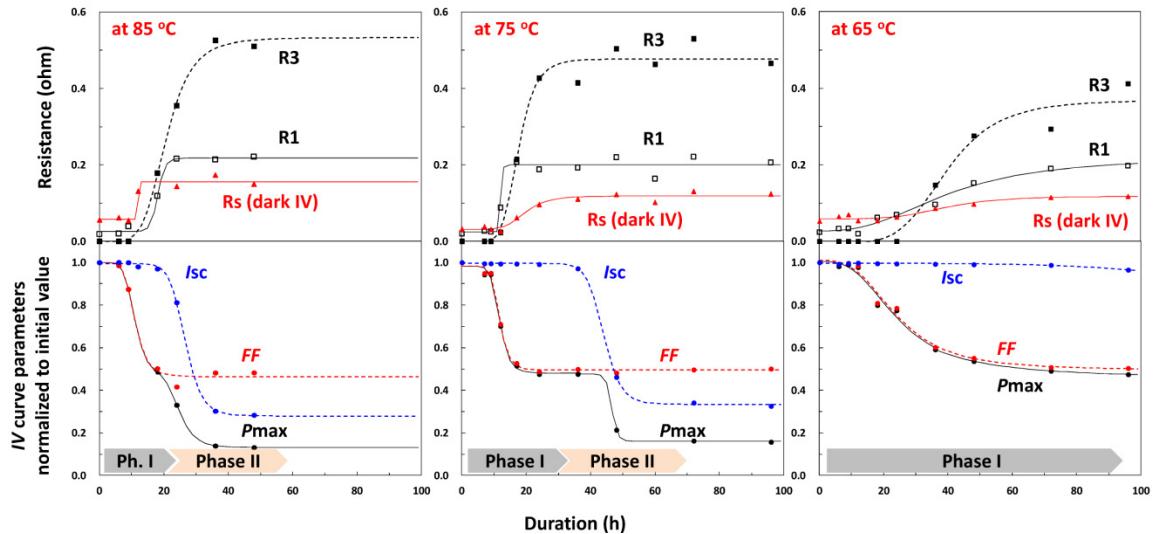
Bare c-Si PV cells promptly degrade by the exposure to the hydrothermal vapours over saturated KCl solution containing 3% HAc according to the exposed duration. However, the degradation is not observed under hydrothermal stress without HAc vapour. The degradation profiles obtained at higher temperatures are divided into 2 phases by the PV characteristics. Firstly, the P_{max} rapidly declined with decreasing FF after a short time-lag (Phase I). Thereafter, the gradual reduction of P_{max} with declining I_{sc} (Phase II) is observed (Fig. 24). These degradation phases may be independent of each other, since their activation energies, calculated using an Arrhenius equation, are slightly different (Fig. 25).

Fig. 24: Phase transition of cell parameter during exposition of PV cells to HAc vapour.

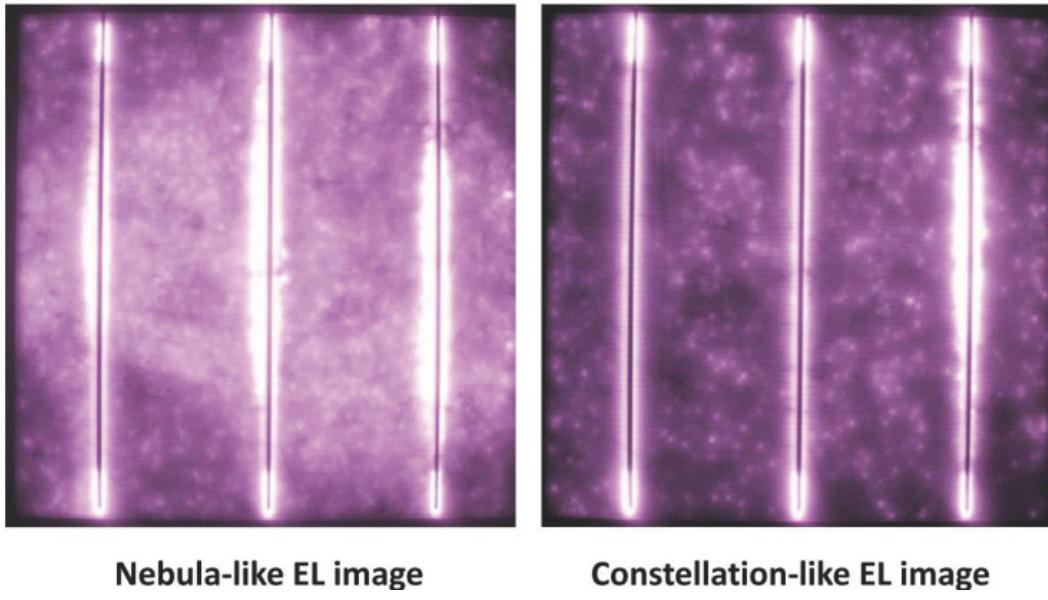
It is worth noting that in Phase I, the development of a new capacitance C_3 , with higher capacitance than that of p-n junction (C_2) is identified by AC impedance spectroscopy (Fig. 26). The increasing series resistance (R_s, R_1) is also detected in the dark I/V curve and AC impedance spectrum. The resistance (R_3), associating with the newly formed capacitor (C_3) rapidly increases through Phase I. During Phase I, the distinguishing transition of EL images is observed, from a nebula-like image characterized by a bright cloud-like area and EL bright points being semi-uniformly distributed in the lower EL brightness background, to a constellation-like image where the bright points sparsely remain only on finger electrodes under the dark EL background (Fig. 27).

Fig. 27: Evolution of EL image during degradation of PV cells exposed to HAc vapour.

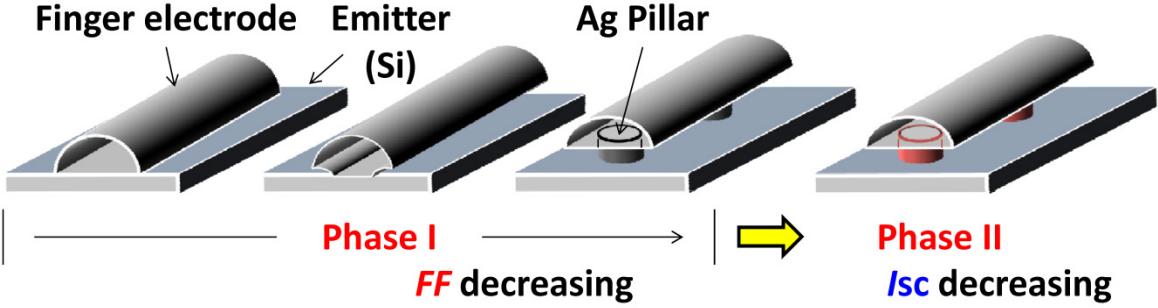
Fig. 28: Putative degradation process of c-Si PV cells exposed to HAc vapour. The red colour of the Ag Pillar in phase II indicates a change of contact properties to the underlying silicon.

These results suggest that the gap underneath the silver gridlines and busbars grows during phase I, although the direct contacts of Ag and emitter surface by Ag pillars seem to remain (Fig. 28). In Phase II, the series resistances R_s and R_1 , the newly developed impedance consisted of capacitance C_3 and the resistance R_3 and FF stay nearly constant (Fig. 24). It should be noted that I_{sc} is decreasing with the evolution of the EL image to complete dark cell areas where the EL emission is limited to only near the cell interconnect ribbon. From these results it is assumed that an addition of a forward-directional diode and/or increased resistivity occurred at the Ag pillars. It has been understood that the current path between emitter and silver finger consisted of two routes (direct contact via Ag pillars and electron tunnelling via nano-Ag colloids dispersed in glass layer [146], [147]). Therefore, it is assumed that the FF reduction during Phase I is induced by dissolution of glass layer-contained nano-Ag particles. In Phase II, the decrease of I_{sc} and the change in blocking characteristics in reverse bias as shown in Fig. 29 suggest that the electric properties in the contact of the Ag pillars are changed, although the precise mechanisms have not been elucidated. Indeed, the gaps formed by the dissolution of Pb-containing glass layer are clearly confirmed in Fig. 30.

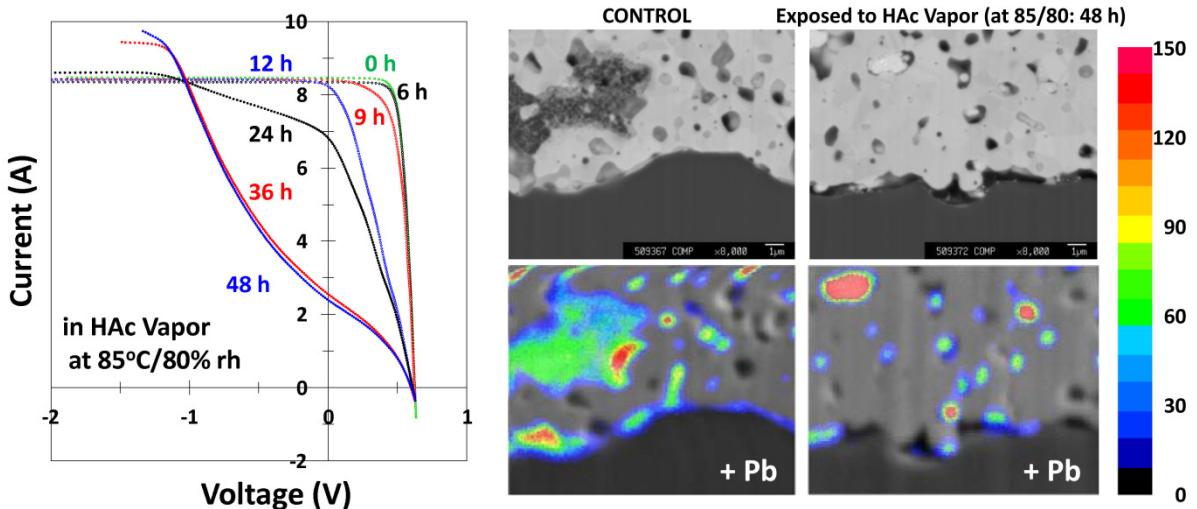
Fig. 29: Evolution of I-V-curve in PV cell exposed to HAc vapour at 85°C/80% rh. The cell starts to lose its diode blocking characteristic in reverse bias after 24 h.

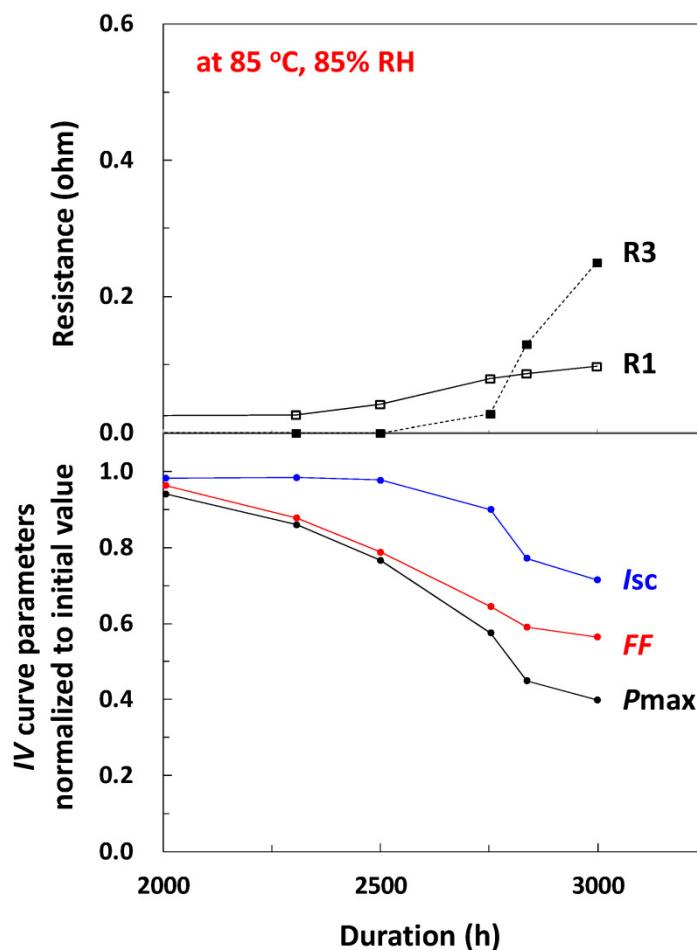
A similar progression in phases of the *IV* and AC impedance parameters with those obtained in PV cells subjected to HAc vapour are observed in the laminated PV cell encapsulated in a conventional module architecture, see Fig. 31. The ingress of moisture onto the PV cell within the PV module progresses from the periphery to the central area on a PV cell in a constant humidity damp heat test [148]. The degradation caused by the diffused moisture is observed around the peripheral area of the PV cell at first, and it is subsequently induced at the central region under the damp heat condition [84], [143]. Because of lateral non-uniform degradation phases occurring even in a one cell module, the electrical signal from each region with different degradation phases may combine and lose their own characteristic feature(s) such as the development of R₃ and C₃, when the signal is obtained from a whole PV cell signal. However, the phase transition of every signal on a PV cell (within a PV module subjected to damp heat testing) can be actually detected. Therefore, it is indicated that the degradation process identified on a bare PV cell exposed to HAc vapour, which seems to be spatial-isotropically degraded, is able to be captured as an “aging signature” even in a PV cell laminated in PV module, which seems to be spatial-anisotropically degraded under the damp heat stress.

Fig. 31: *IV*-curve and AC impedance parameter of a PV mini-module as function of the damp heat stress duration.

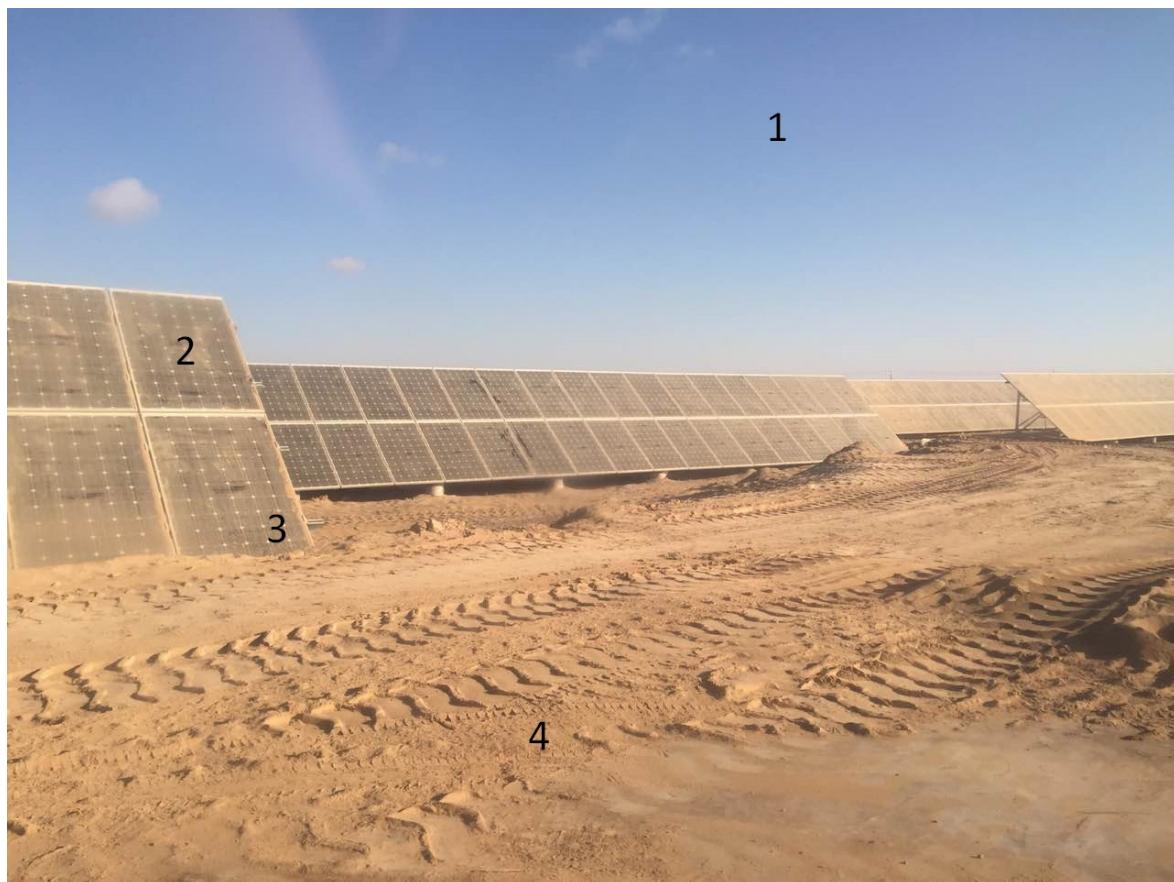
Fig. 32 illustrates the various factors, which impact dust soiling of PV modules. The photo also shows that specific Operation & Maintenance (O&M) measures, such as periodic cleaning, will be required to ensure economic operation of PV power plants in desert regions.

Fig. 32: Factors influencing dust soiling of PV modules in desert regions: 1 Climatic impact, ambient dust concentration, 2 Glazing characteristics, adhesion effects, non-uniform soiling, 3-Installation conditions, 4-Surrounding environment, dust particle characteristics. Photo: TÜV Rheinland Group

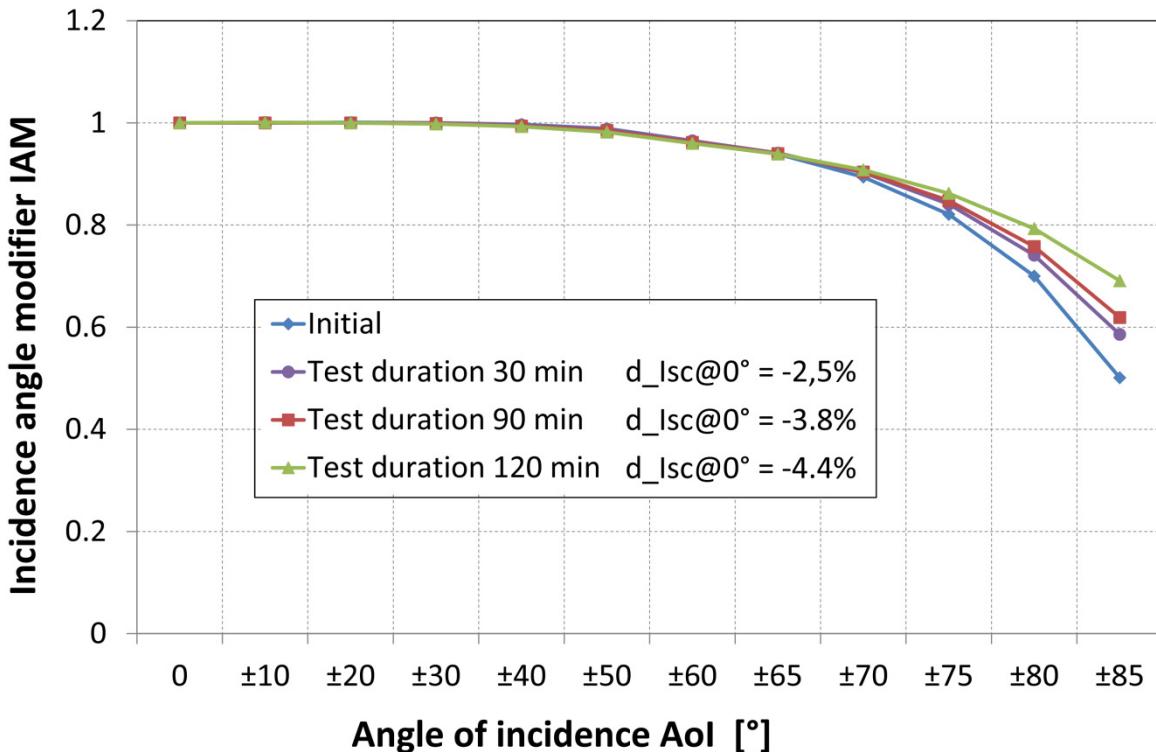
Regarding module failures caused by dust soiling, the predominant failure mode is abrasion of the module surface, which can be either caused by natural weathering (sand blasting) or frequent cleaning. Abrasion of the PV glass surface is not a type of defect which would normally affect the reliability of PV power plants or lead to safety risks, but it will cause performance losses due to deterioration of optical transmittance. Depending on the installation conditions and the frequency of sandstorms, abrasion effects can also occur on the rear side of the PV module. For polymeric backsheets weathering effects are more pronounced compared to PV glass, which might result in safety and reliability risks. For quantifying abrasion effects the short-circuit current of a PV module, which is correlated with the optical transmittance, is a suitable parameter. It is measured in +/-85° Angle of Incidence (AoI) range as described in the standard IEC 61853-2 [166]. As an example Fig. 36 illustrates the change of the angular characteristics of solar glass during a blowing

sand test according to MIL-STD-810G. After 120 minutes of exposure the entire AR coating was abraded. The data also reveal that transmittance loss at normal incidence can be partially compensated by better angular response for large AoI.

Fig. 36: Change of the angular characteristic of a PV module with AR coated glass caused by blowing sand test in accordance with MIL-STD-810G.

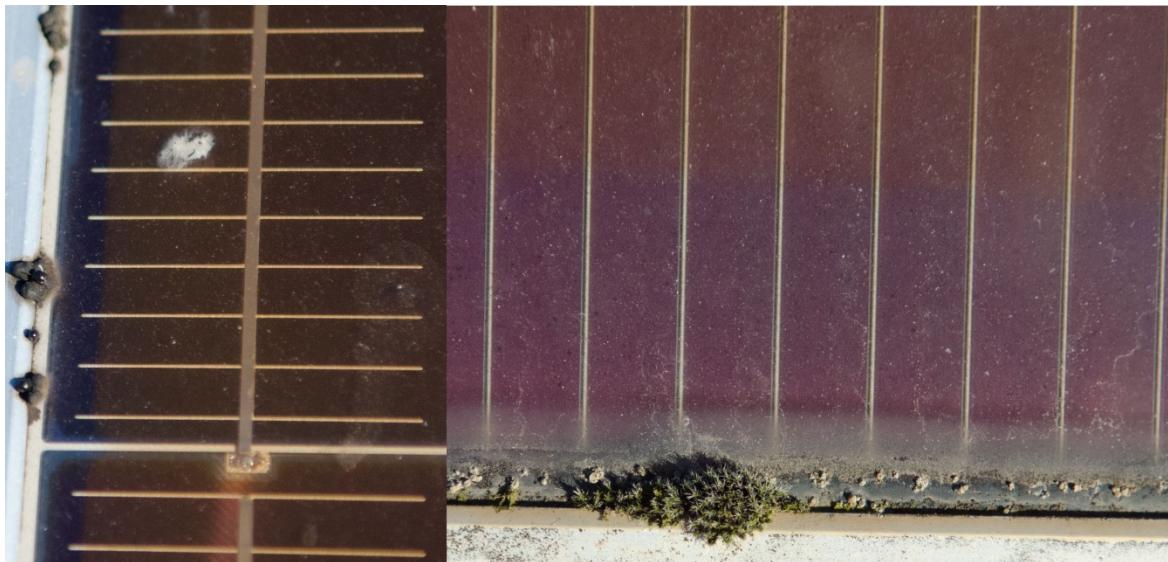
Fig. 38: Example of bird droppings (left) and moss (right) on a PV module.

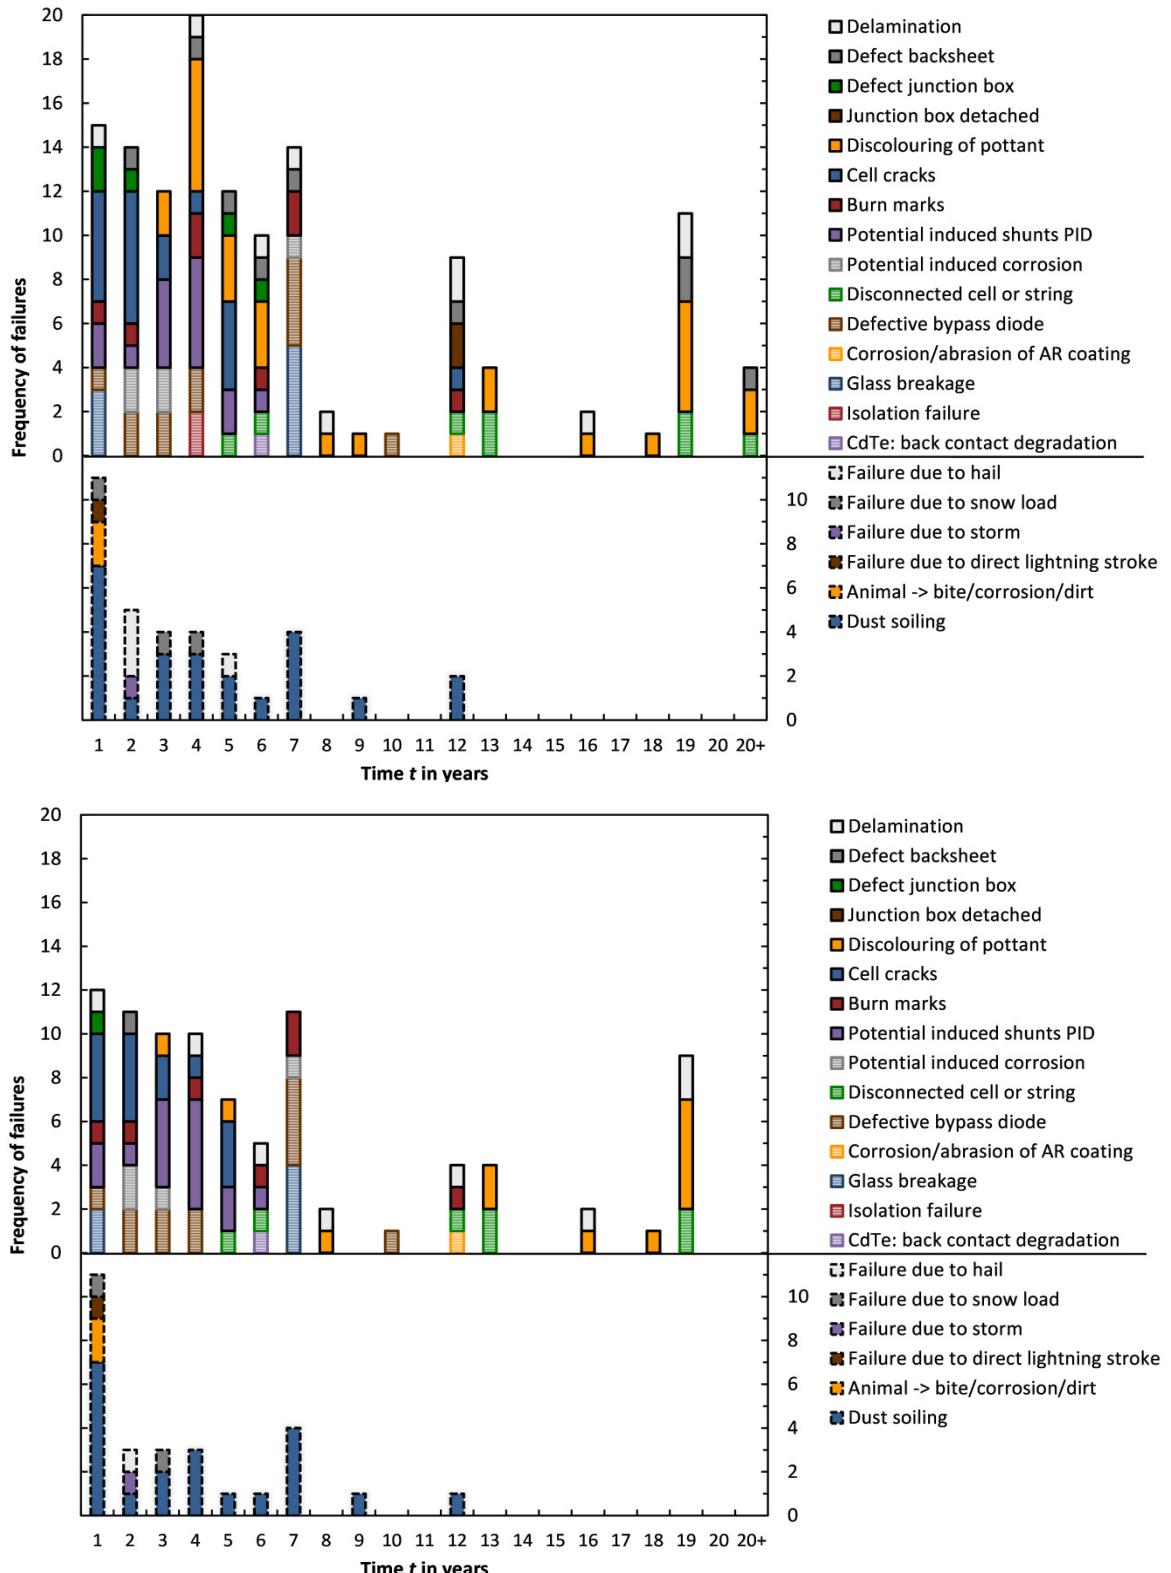
Before we evaluate the degradation rates we show the occurrence of failures over the years of operation in Fig. 49. The upper diagram shows the occurrence of all reported failures, and the lower graph shows only failures causing a power loss. Each diagram is split into the occurrence of degrading failures and sudden occurring failures. The occurrence of both failure types accumulates at the first 7 years.

When we focus on special types of failures we see that cell crack failures are mostly reported in the very early stage of PV system operation from year 1 to year 2. Systems with PID-s failure are mainly reported during year 3 and year 4. Disconnected cells or strings in the module are reported after year 4 spread over the whole operation time. Discolouring of pottant is spread over the years, but power relevant discolouring starts after year 3 with a high accumulation after 18 years of system operation. Defect bypass diodes are spread over the first 10 years of operation. The total occurrence of the other failures is too seldom for detailed discussion.

Fig. 49: Occurrence distribution of failures over the years of PV system operation. The failure occurrence is split into degrading failure and sudden occurring failures. The upper graph shows the total failures occurrence of all detected failure. The lower graph shows the occurrence of detected failure which causes a measurable power loss.

The distribution of failure occurrences over the operational years of the PV system deviates from a typical bathtub curve. A reason for the difference may be that the number of installed systems changes exponentially with the year of installation. We have much more young systems in the world than old ones as shown in Fig. 55. Therefore, the failure occurrence is highly biased by a not constant annual system installation rate. This may be the reason for the high failure level at the first seven years in Fig. 49. Especially the suddenly occurring failures are highly biased by this effect.

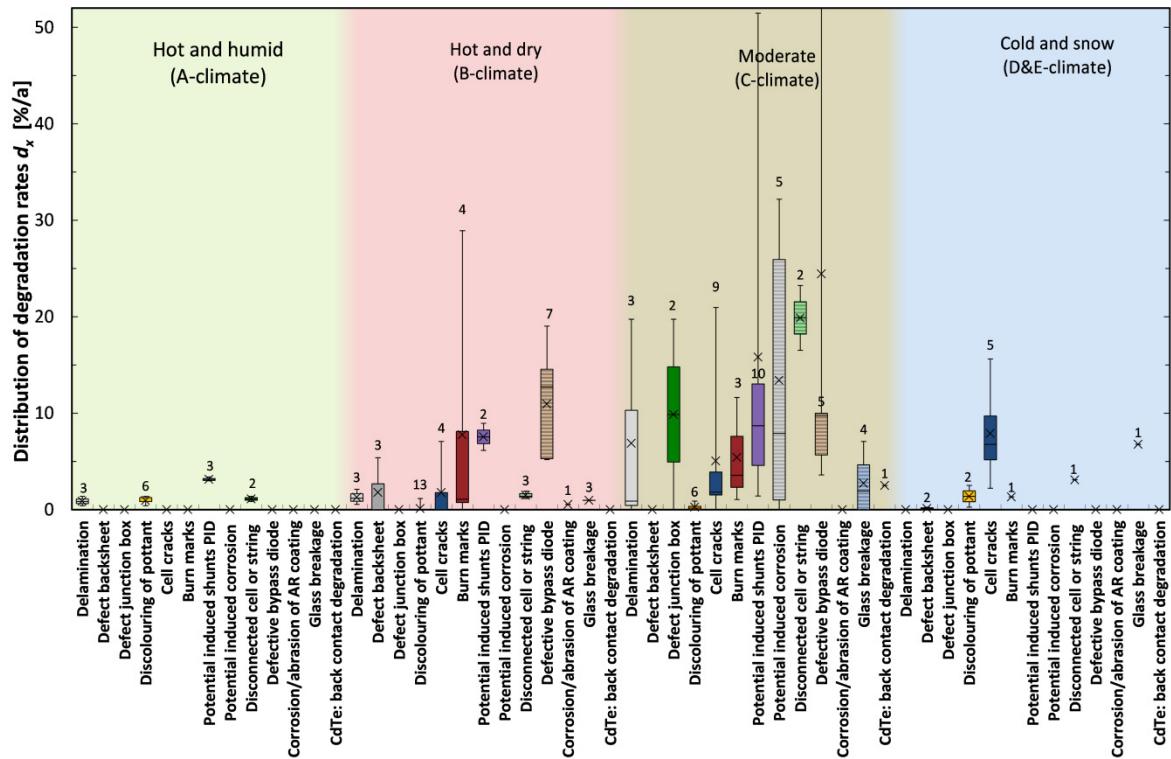
Fig. 50 shows the unweighted degradation rates for the affected part of the PV systems calculated by Eq. (28). The highest impact on the performance of PV modules have defective bypass diodes in the hot and dry climate with 11%/a and in moderate climate with 25%/a. The degradation rate caused by cell cracks in the cold and snow climate is about 3%/a higher than in the moderate climate and 6%/a higher than in hot and dry climate. The PID-s effect shows a mean degradation rate of about 15% per year. In the moderate climate it is the most often found failure together with a high degradation rate. Unfortunately there are not enough PID-s events documented from other climate zones. The discolouring of encapsulant (pottant) failure is found in the hot and humid, hot, and dry and in the moderate climate as well. In the three climate zones this degradation mechanism is in the mean below 1%/a. Therefore, this effect is most often not the cause for warranty claims.

Fig. 50: Box plot of degradation rates dx of PV module affected by failures x sorted by climatic zones. The numbers show the quantity of data per failure in the database. The cross shows the mean degradation rate.

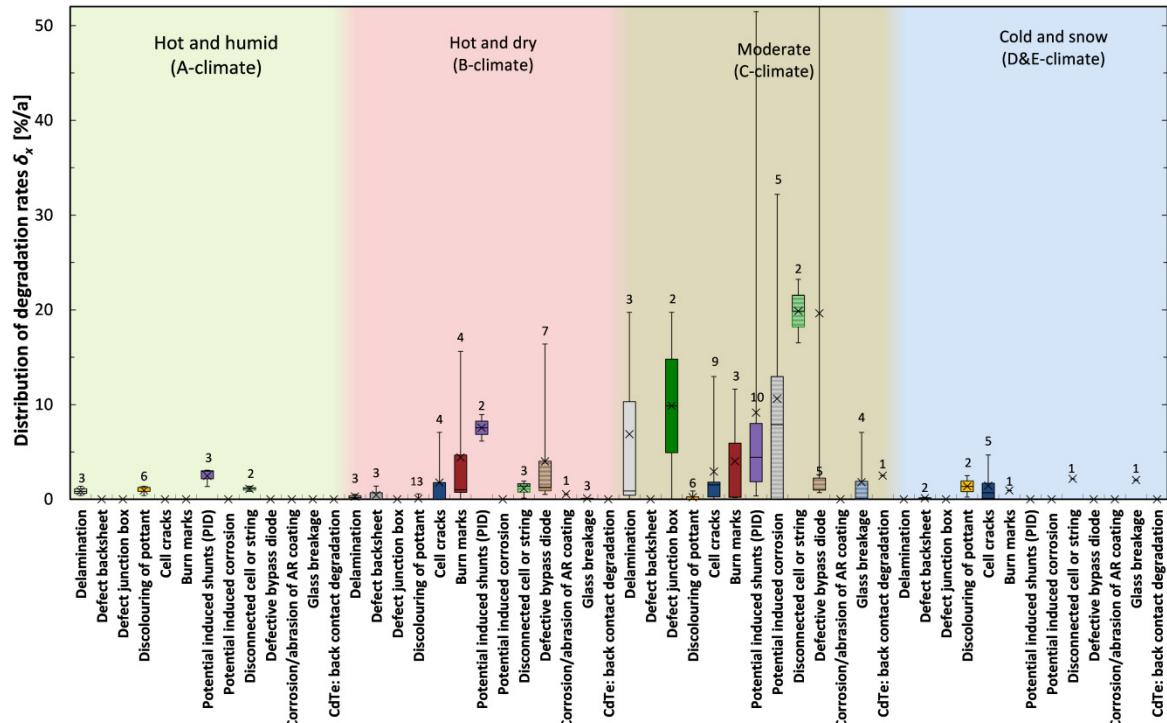
How much a failure dominates the total system power can be seen by the unweighted degradation rate of the investigated system part calculated by Eq. (29) shown in Fig. 51. For the PID-s effect in the moderate climate the degradation of the investigated system part is reduced by 3/5 compared to the degradation of the affected system part. Therefore, PID-s affects in average

about 3/5 of a system in the moderate climate zone. For cell cracks the same evaluation shows that cell cracks affect about 3/5 of the system in the moderate climate zones if they cause a power loss.

Fig. 51: Degradation rates of the investigated PV system part of PV module failure sorted by climatic zones. The numbers show the quantity of data per failure in the data-base. The cross shows the mean degradation rate.

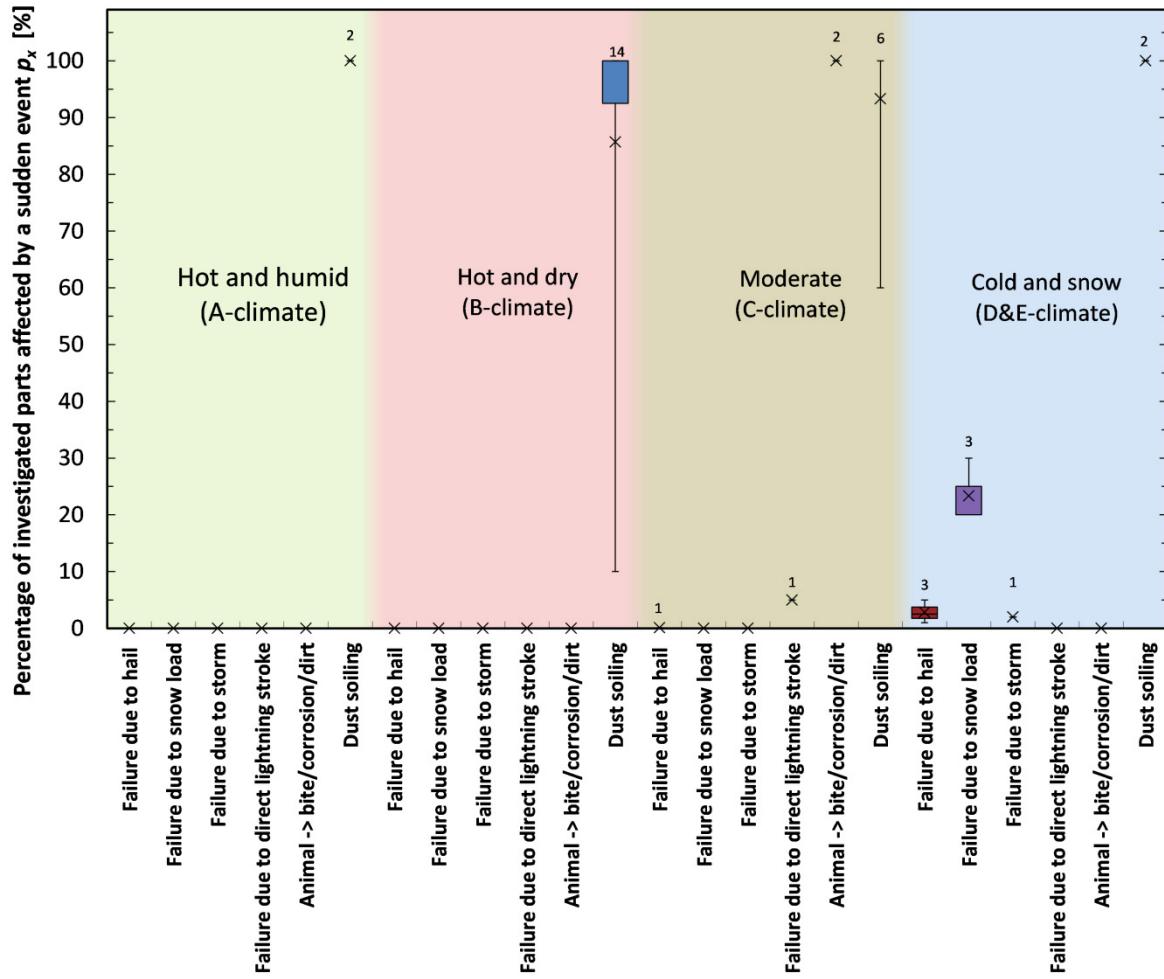
Fig. 52 shows how much of a system is affected by a sudden event calculated by Eq. (33). As expected, soiling affects almost the whole systems in nearly all cases. There is one event of “Animal -> bite/corrosion/dirt” where animals also soil all of the modules. The events “lightning strike”, “storm” and “hail” only cause a power loss on less than 10% of the modules in the system. The failure “snow load” affects about 20% of the modules in the system.

Fig. 52: Box plot of percentage of system part affected after a sudden event. The numbers show the quantity of data per failure in the database.

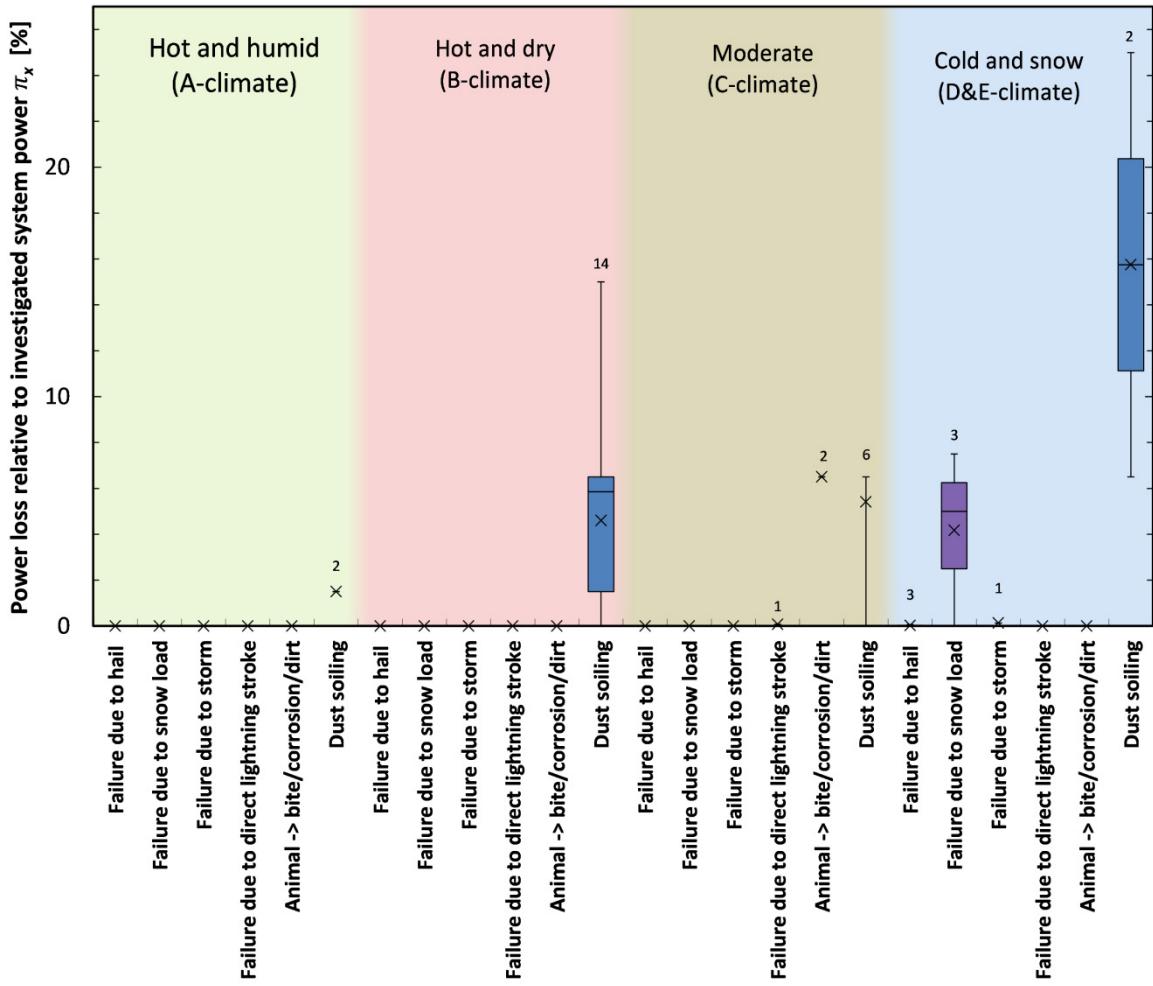
The power loss of a system caused by a sudden event is calculated by Eq. (32) and is shown in Fig. 53. Besides soiling, snow load events have the highest impact on the system power loss. The failure “snow load” affects about 20% of the modules in the system and has an impact on power output of ca. 4%. Other events, such as lightning strikes, storm, and hail only cause a power loss on less than 10% of the modules of the plant and seem to affect less than 1% of the total system power output. Except for soiling the calculations in Fig. 52 and Fig. 53 are mostly based on single to three entries in the database and are therewith only show cases.

Fig. 53: Box plot of percentage of system power lost from the investigated system part after a sudden event. The numbers show the quantity of data per failure in the database.

The failure type soiling does not fit into the degrading and sudden failures categories, because the power of soiled module degrades over time, but can fully be recovered. We see a dependence of dust soiling on the climate zones in Fig. 53. However, the high mean power loss due to dust in the moderate C zone (6%) does not coincide with the expectation of finding higher dust soiling losses in the hot and dry B climate zones (4%). Probably dust soiling is strongly influenced by local conditions. Herrmann developed a model of dust soiling based on weather data and other influencing factors [205]. He showed a correlation between desert and non-desert regions. To prove this correlation we would need a much more detailed climate zone resolution than performed in this study.

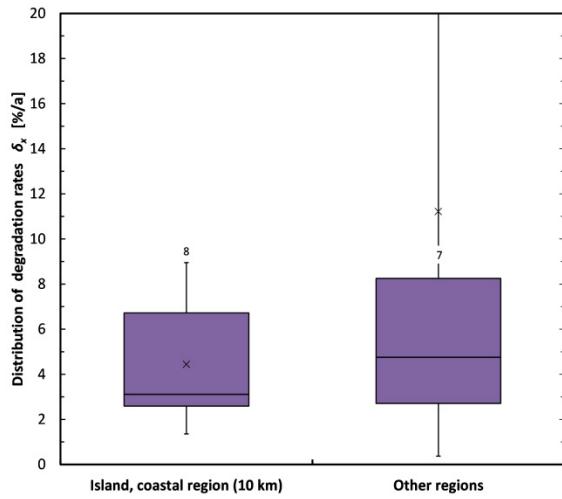
72% of all reported failures with the special stress loads “Island, coastal region (10 km)” show a PID-s failure. From the rest data only 4.6% show PID-s. This indicates much higher PID-s risk for island and coastal regions as also found by Berghold [203]. Therefore, one would expect a much higher PID-s degradation rate for “coastal regions/island” systems. But this is not the case. The total degradation rate of the coastal regions/island systems is shown in Fig. 54 in comparison to all other systems. The mean PID-s degradation rate is much higher for other regions than for “coastal regions/island” systems. However, this is caused by some systems in other regions with an extreme high degradation rate.

Fig. 54: Box-Whisker-Plot of degradation rate of the investigated part of the system for the PID-s effect sorted by the special stress coastal region and other. The mean value is indicated by a cross.

The anti-correlation between mean degradation rate and occurrence of PID-s in coastal regions/island systems is unexpected. Berghold presented a classification of PID-s modules into “Frame PID-s” where only the cells close to the frame are affected and “Surface PID-s” where almost all cells are affected [203]. The different affected area of the PV module serves to partition the results and influence the observed degradation rates. Berghold suggests that the “Frame PID-s” with the low degradation rate is found in hot and dry locations. But in our database only two island/coast region systems are from hot and dry locations. Therefore, this “Frame PID-s” effect cannot explain the relative low degradation rate for island/coast region systems compared to other regions. But there may be some systems among the other region systems that show “Surface PID-s” leading to very high degradation rates that influence the statistic.

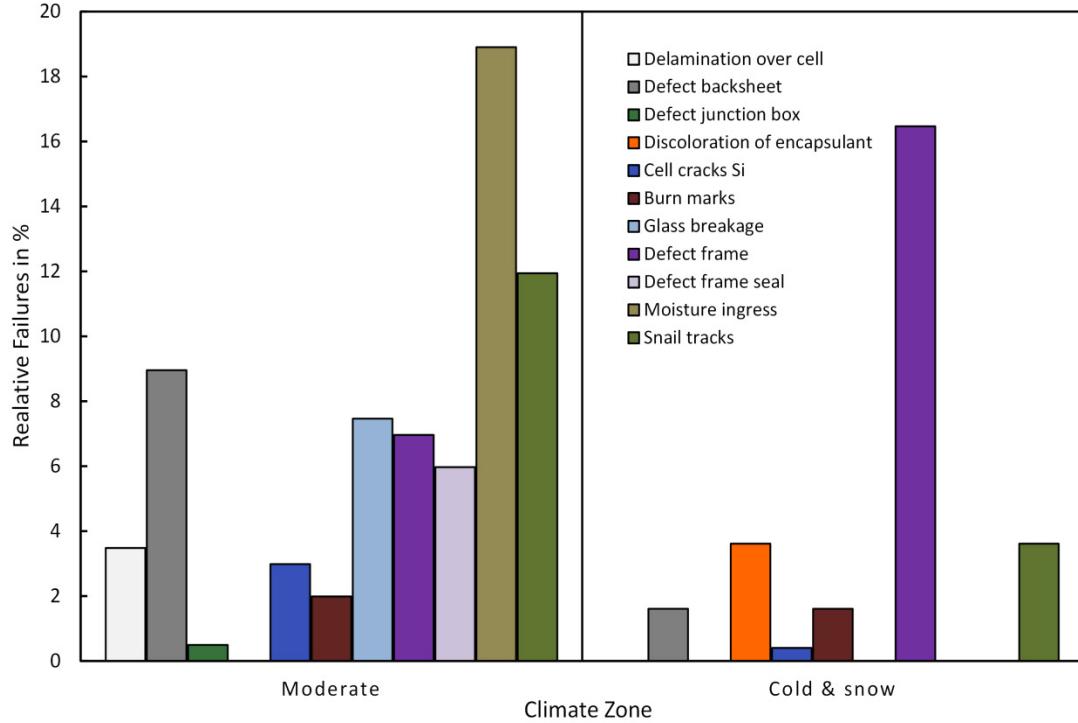
The distribution of the occurrence of PV module failures over the climate zones are grouped for the 3 different PV module technologies: Si PV modules (455), CdTe and CIGS modules (655) and a-Si PV modules (96). For the first group, failures are detected in moderate C and cold & snow D/E climates, but not in hot & dry climates A due to the low number of inspected Si modules (5). When we focus on the specific types of failures of Si modules, we find that moisture ingress (19%), defect frame (17%), snail tracks (12%), and defect backsheet (9%) are the most frequent failures for this technology (see Fig. 60). The percentage given is the observed occurrence per failure type compared to the total number of inspected modules of this technology and in this climate zone. Thus, we find that moisture ingress and snail tracks are the prominent failure types for moderate climate, while defect frame are dominant for Si modules in cold & snow climates.

Fig. 60: Distribution of silicon PV module failures in the field classified in different climate zones according to Köppen-Geiger climate classification system [207].

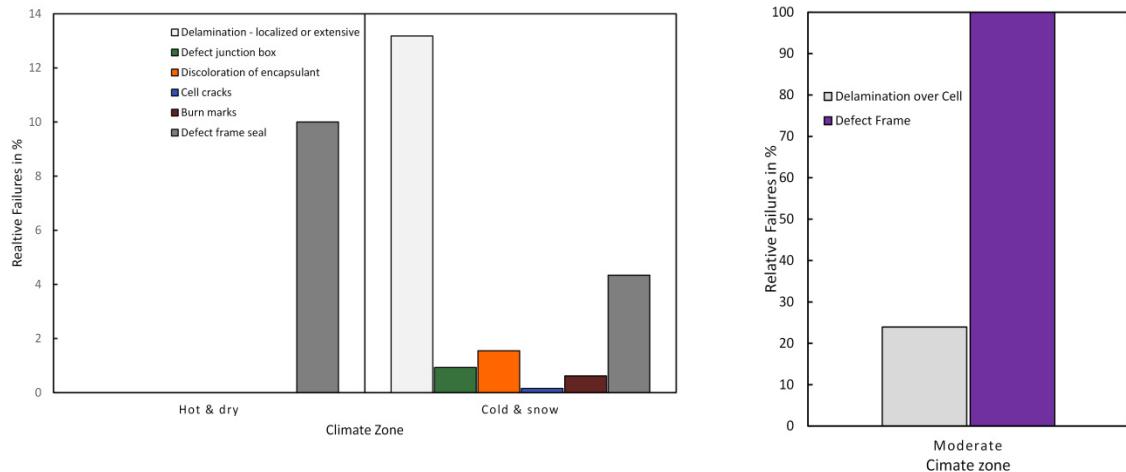
The distribution of failures CdTe and CIGS modules (see Fig. 61) is only relevant for the cold & snow climate (645) due to the low number of those modules in hot & dry climate (10). The dominant failure type for this group is delamination – small, localized - with 13%, followed by defect frame seal with 4%.

Fig. 61: Distribution of CdTe and CIGS module failures in the field classified in different climate zones according to Köppen-Geiger climate classification system [207].

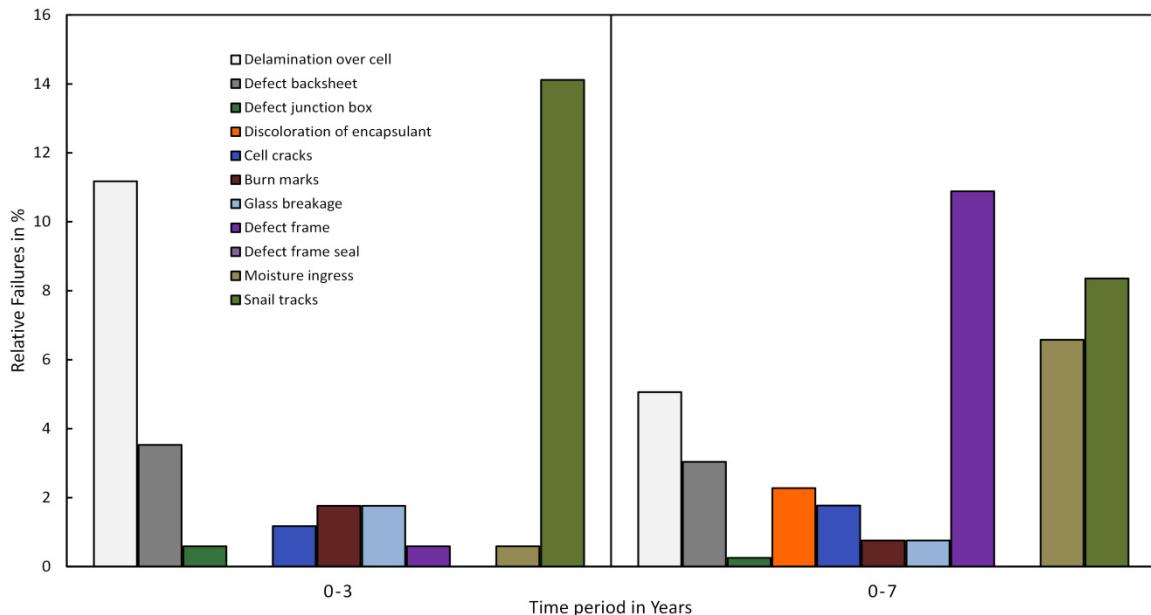
The cumulative distribution of the failure types over the period between inspection and installation for Si PV modules is shown in Fig. 63 grouped in two time periods, 0 to 3 years (170 modules) and 0 to 7 years (395 modules). For the first three year period, snail tracks (14%) and delamination over cell (11%) are the dominant failure types. For the cumulative failures during the period 0 to 7 years, the relevant failures types are defect frame (11%) and snail tracks (8%). Thus snail tracks seem to primarily appear during the first 3 years after installation, while the defect frame requires a longer module exposure time than 3 years in the field. This confirms the experience that snail tracks show up during the first half year after installation [1].

The observation of a significant increase of failures of the defect frame type (1% vs 11%) and the moisture ingress type (1% vs 7%) from time period 0 to 3 years to time period 0 to 7 years can demonstrate a possible correlation between these two failures. Furthermore, according to the nature of the failure moisture ingress, it is more likely to happen when failures such as glass breakage and defect frame have already occurred. Another important factor to be considered is the aging of the PV modules which is different for the two exposure periods. In the time period from 0 to 3 years, at least failure was detected for 35% of the inspected modules. On the other hand, during time period 0 to 7 years, at least one failure was detected for 40% of the inspected modules. This deviation of more than 12% in detected failures between the two time periods can be due to the aging factor.

Fig. 63: Cumulative distribution of normalized failures over time periods between installation and inspection dates for fielded silicon PV modules. Soiling is not included in this graph.

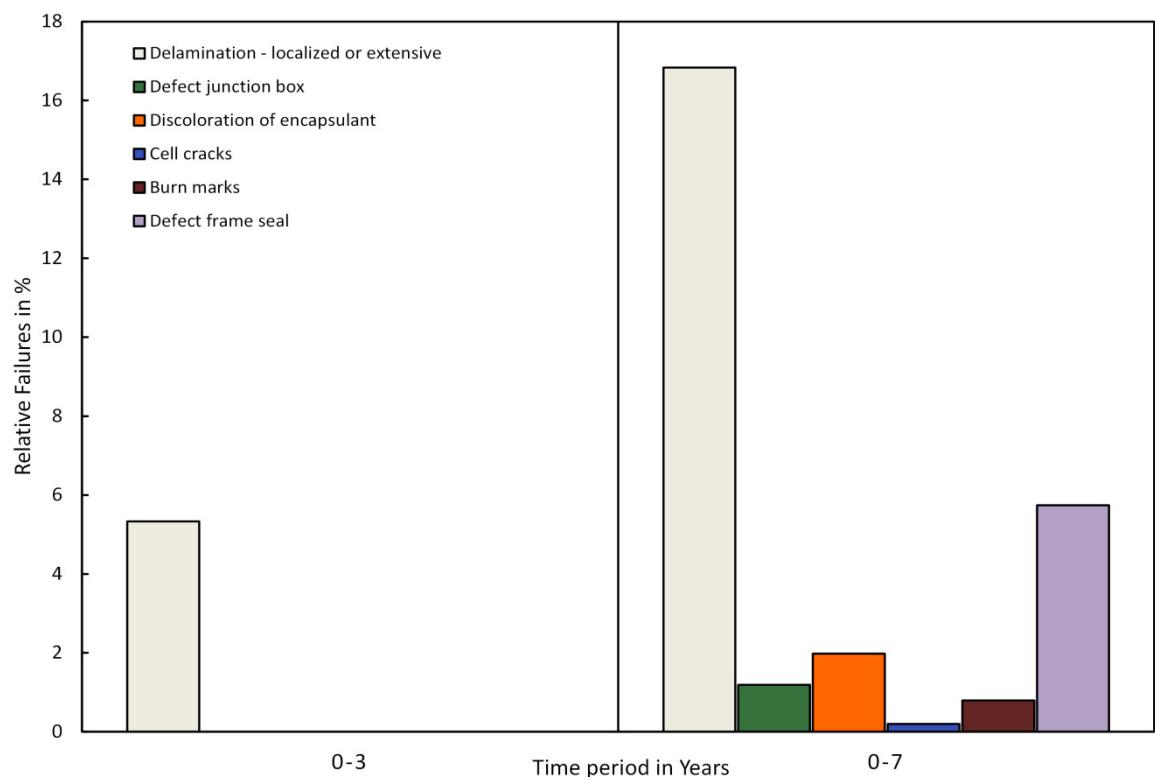
The cumulative distribution of the failure types for fielded CdTe and CIGS modules is shown in Fig. 64 grouped in the same time periods, 0 to 3 years (150 modules) and 0 to 7 years (505 modules). For the first period, delamination - small localized (5%) - is the only and dominant failure type. In the cumulative distribution during 0 to 7 year-period, this failure type increases to 17%, followed by defect frame seal with 6%. We can therefore conclude that delamination of CdTe modules seem to increase by a factor of 3, based on one module type and on inspection at the same location.

Fig. 64: Cumulative distribution of normalized failures over time periods between installation and inspection dates for fielded CdTe and CIGS modules. Soiling is not included in this graph.
